## **Innovative approach to real-time diagnostic of bolted joints and elastic couplings to prevent their fractures**

D. Gorbacovs\*, P. Gavrilovs, J. Eiduks and M. Gailis

Riga Technical University, Faculty of Mechanical Engineering, Department of Railway Engineering, Transport and Aeronautics, LV-1048 Riga, Latvia

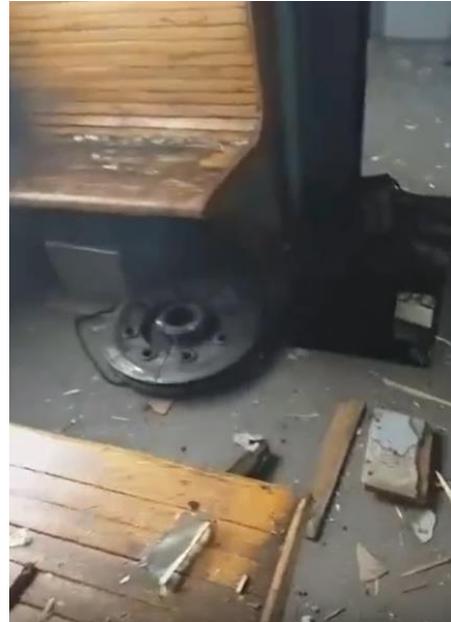
electric train or the car body. The disc of the inner flange can also get into the cabin of the car through the viewing hatch, causing damage to the cabin and even injury to the passengers, (Fig. 1).

This case took place on the Latvian Railway, when during the movement of an electric train, 5 bolts securing a rubber-cord coupling broke. As a result, the half-disk fastening the rubber-cord coupling flew into the car interior, breaking the protective grille and piercing the inspection hatch of the motor car (Fig. 1).

**Figure 1.** Ejection of the flange of the rubber-cord coupling in the passenger compartment.

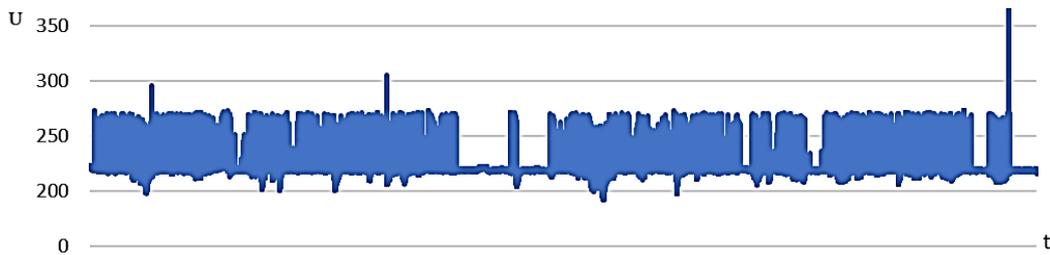
The results obtained from the impact monitoring device for bolted anchorages and rubber cord are shown in (Fig. 10).

(Fig. 10) shows the amplitudes of vibrations (in conventional units) taken from the vibration sensor while the motor car is moving. Measurements were carried out throughout the day (24 hours). As can be seen from the graph, the amplitude of the vibration was at around 280 conventional units. However, 3 cases were recorded when the amplitude of oscillations reached up to 300 conventional units. The maximum amplitude of oscillations was 396 conventional units. The mileage of the car is 486 km.

**Figure 10.** Shock vibration load graph for one working day.
