## **Influence of coconut fiber incorporation on the mechanical behavior of adobe blocks**

**Key words:** adobe, coconut fiber, rural buildings.

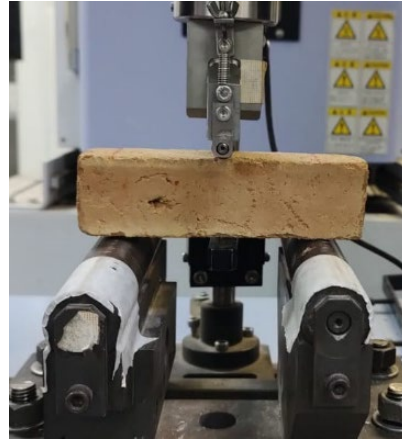
**Figure 2.** Three-point flexural test.

The flexural test was conducted using a Shimadzu Universal Testing Machine with a loading capacity of 100 kN. The test speed used was 0.3 mm min<sup>-1</sup>. Prismatic specimens measuring (40×40×160 mm) were positioned for the three-point flexural test with a support span of 120 mm (Fig. 2).

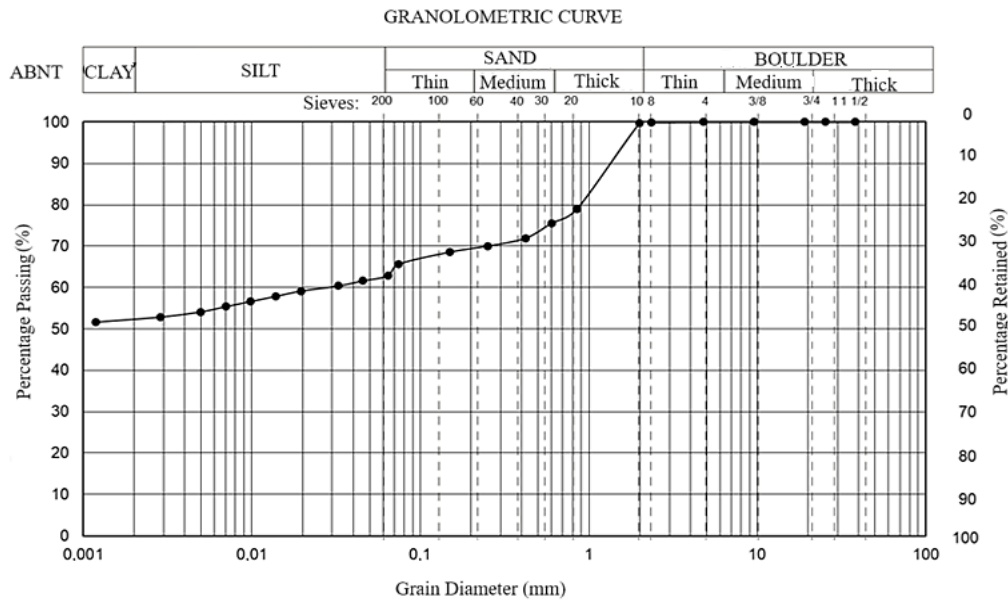
**Figure 3.** Granulometric distribution curve of the soil.

The grain size distribution curve of the soil is presented in Fig. 3, where the grain diameters and the percentages retained and passed through the soil are observed, according to the distribution of sieves described in NBR 7181 (ABNT, 2016).

The grain size composition of the soil (Table 1) showed a higher concentration of clay (52%), followed by sand (37%), and finally silt (10%). According to NBR 16184 ABNT, 2020), the grain size composition should preferably meet (the following parameters: sand (between 45% and 65%); silt (up to 30%); and clay (between 25% and 35%).

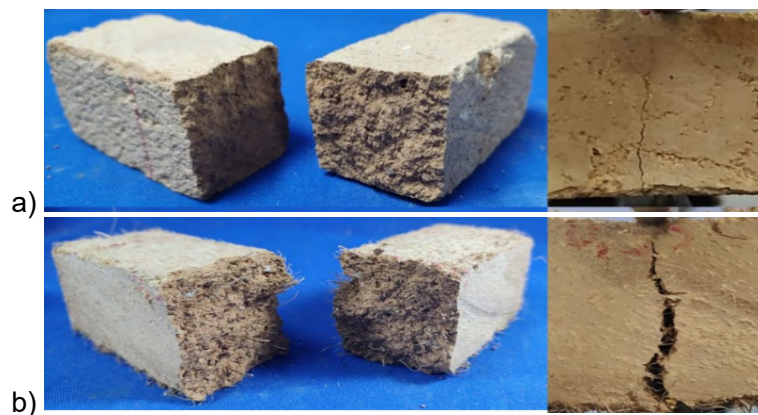
**Figure 9.** Adobe samples after the bending test:(a) Reference and (b) 2% fiber.

In regards to the three-point bending test, only the reference adobe blocks and those with 2% fiber were tested, as it has the highest volumetric fraction of fibers. The values obtained for flexural strengths (Fig. 8) for the reference adobe block were 0.61 MPa (6.8), and for the samples with 2% fiber, the strength was approximately 0.56 MPa (9.4).
