Comparison of the technological and building situation of Estonian cowsheds in 1999 and 2004

Abstract. In 1999 an investigation of the situation of Estonian cowsheds was carried out under the leadership of the Institute of Rural Building of the Estonian Agricultural University. The aim of the research was to determine the dominant building structures of cowsheds and find out what kind of technologies were used there. This research helped to clarify the situation and allowed to make proposals as to which problematic areas should get the attention of help funds of the European Union.

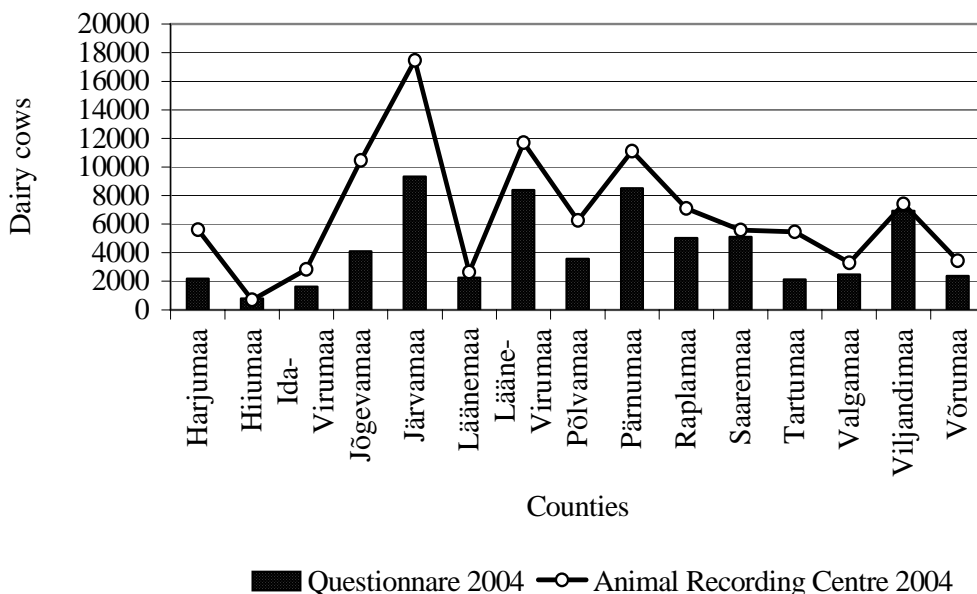
Fig. 1. Distribution of dairy cattle by counties.

Both selections are large and represent the whole picture quite well. If we compare the structure of data set by counties gathered by the questionnaire in 2004 with the data of the Animal Recording Centre (Structure ..., 2005; Table 3), the correlation coefficient $r = 0.89$. The result of F -test is 0.084, which means that the difference of variability of the two sets is not proved on the significance level $P = 0.05$. The conclusions derived from the database obtained with the questionnaire can therefore be transferred to the general whole. It is visible from Fig. 1 that, by counties, the number of cows belonging to the farmers who were questioned generally follows the number of Estonian dairy-cows under performance-check. The only discrepancy is in Hiiu County, where many cows are probably not under performance-check (it is located on an island, far from the Animal Recording Centre).

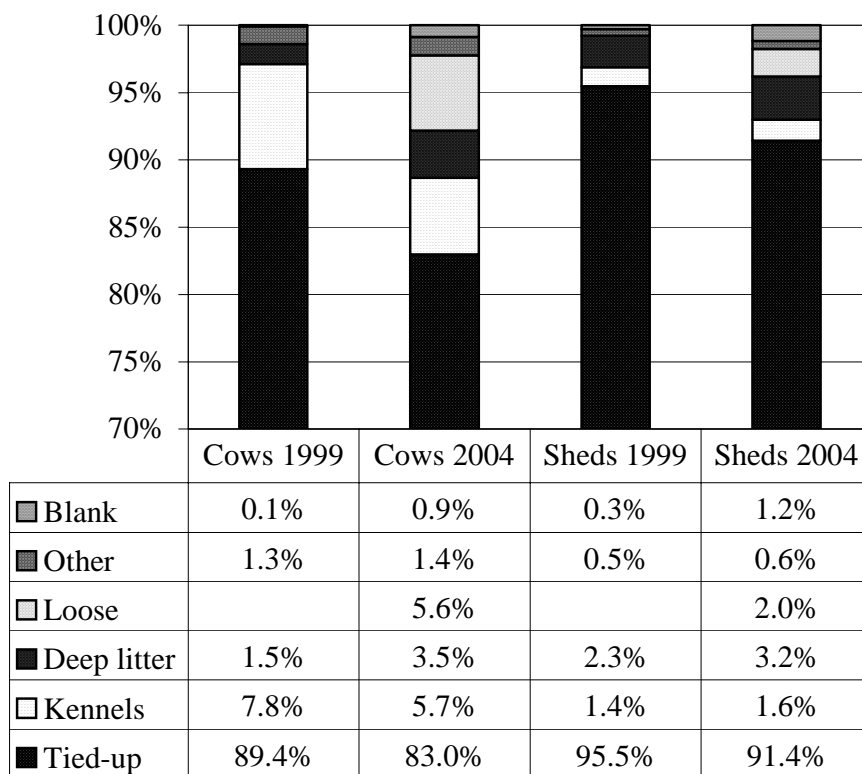
Fig. 2. Change of systems of housing from the total number of cows in percents and from the total number of cowsheds in percents.

During the past five years, the housing systems of cows in Estonia have changed somewhat. There has been a shift from tied-up to loose housing but the change has been only 5–6% in the number of cows and 4% in the number of cowsheds (Fig. 2). Loose housing means housing in kennels, housing on deep litter and loose housing summarised.

Although loose housing has increased 1.5 times in 5 years (from 1999 to 2004) for the number of cows and 1.8 times for the number of cowsheds, still only 15% of dairy cows are under loose housing system. The change is also too small for the milking methods. Replacing milking into a churn with parlour milking should get more attention than switching from milking into a churn to milking into a pipeline.

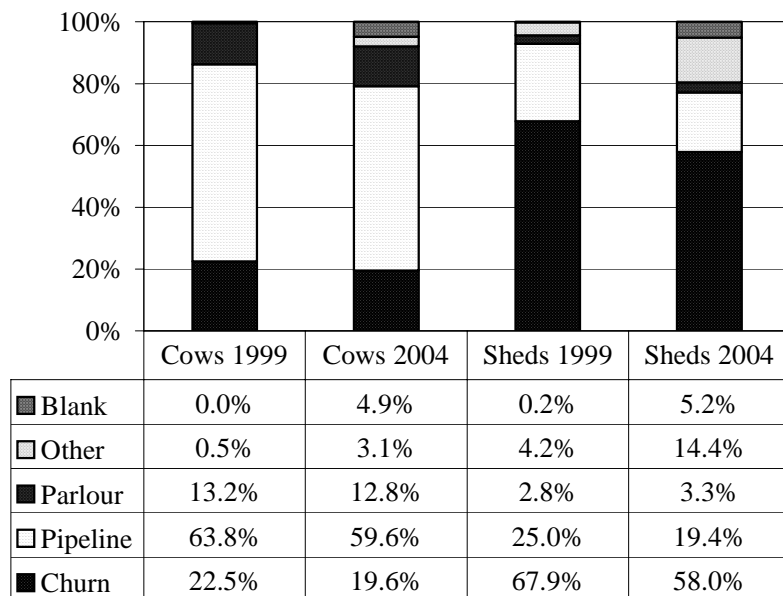
Fig. 3. Change of systems of milking from the total number of cows in percents and from the total number of cowsheds in percents.

Considering the efficiency of the milker, it is important that the number of cows and cowsheds where milking is performed on a parlour has increased. Analysing the data from the questionnaire from the aspect of milking methods, it appears that the number of cows milked into a pipeline or on a parlour (Fig. 3) has almost not changed. The number of cows milked into a churn has decreased and the number of cows whose owners could not specify the milking method has increased.

In the number of cowsheds separated by the milking method (Fig. 3), pipeline milking has decreased by 5.6% and parlour milking has increased by 0.5%. The number of cowsheds where cows are milked into a churn has decreased and the number of cowsheds whose owners could not specify the milking method has increased.

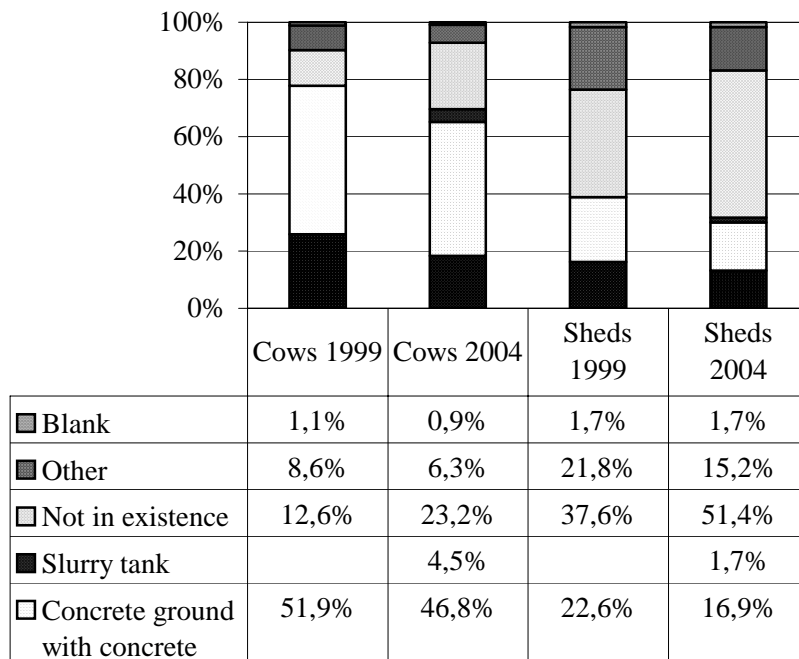
Fig. 4. Manure storage from the total number of cows in percents and from the total number of cowsheds in percents.

From the environmental point of view, the method of manure storage is relevant (Fig. 4). The greatest role in manure storage is played by reinforced concrete storages and concrete grounds. This applies to both the number of cows and the number of cowsheds. Surprisingly, the relative importance of concrete storages and -grounds has significantly diminished during the past five years. The frequency of manure storage without proper facilities has increased by both the number of cows (almost two times) and the number of cowsheds (over 1.5 times). This can be caused by the fact that numerous cowsheds with storages in a poor condition were listed as 'without storage'. This was possibly caused by a non-refundable aid project launched at the end of 2004 for improvement of manure processing. The point that in 2004 the manure of almost 5% of the cows was stored in slurry tanks should be considered a positive trend.

Despite the construction of several manure storage facilities in Estonia that meet European standards, the total number of manure storage facilities has diminished according to the questionnaire. As a positive fact, it can be noted that during the five years there has been a shift in the awareness of the cattle-breeders and they have answered differently to the same question about the existence of manure storage facilities in 1999 and 2004. The cattle-breeders are now aware of the European requirements on manure storage and the subsidies that are available for upgrading the facilities. Despite the increase of awareness, it will not be possible to reconstruct all the manure storage facilities during the remaining two years, by 2007.

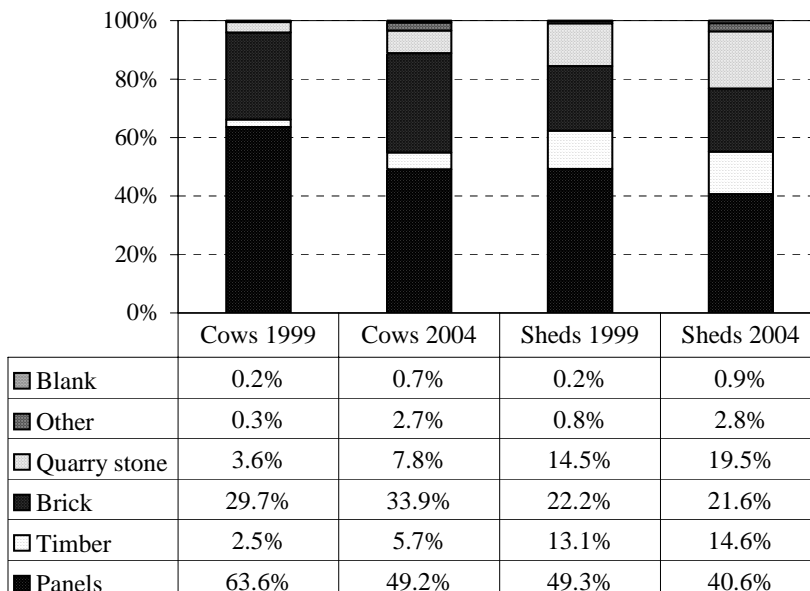
Fig. 5. Material of walls from the total number of cowsheds and from the total number of cows in percents.

In 2004, 40.6% of Estonian cowsheds housing more than five animals had wall-structures of gas-concrete (Fig. 5). In five years their significance fell by over 9%. By the number of cows, over 50% were still in buildings made of panels but here also a decrease of the relative importance is considerable – over 15%. The number of cowsheds with wooden walls has risen, but mainly among the smaller cowsheds.

Lately changes can be noticed in the structures of the existing Estonian cowsheds. For example, the number of cowsheds with gas-concrete walls has decreased. There are also some changes in regard to the weight-bearing structures. The percentage of reinforced concrete columns has fallen while the percentage of wooden columns has risen. The same trend can be noted with beams, where reinforced concrete is losing its importance, and there are more and more wooden beams.

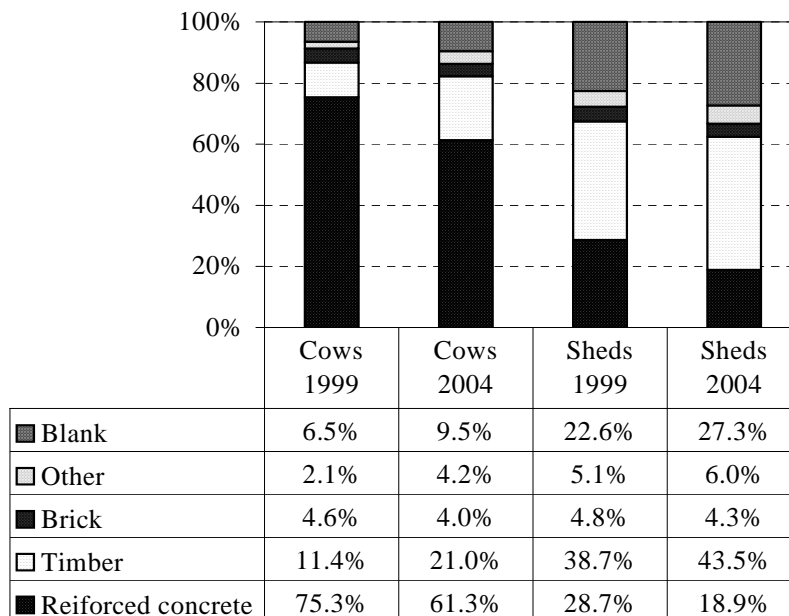
Fig. 6. Material of columns (from the total number of cowsheds and from the total number of cows in percents).

In regard to bearing structures, cowsheds with reinforced concrete columns have lost their significance (Fig. 6). By the number of animals, however, most cows (61.3%) are still housed in buildings with reinforced concrete columns. The importance of cowsheds with wooden columns has risen, but primarily among smaller cowsheds as 43.5% of the cowsheds have wooden columns but they all house only 21% of the cows.

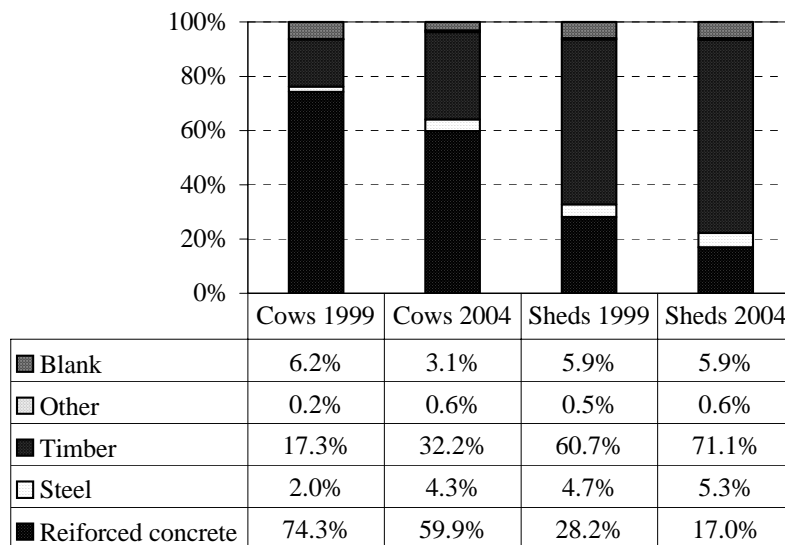
Fig. 7. Material of beams (from the total number of cowsheds and from the total number of cows in percents).

By the number of cowsheds, buildings with wooden beams have achieved a clear majority and, by the end of 2004, they included 71.1% of the cowsheds with five or more animals (Fig. 7). By the number of animals, however, most cows (59.91%) resided in cowsheds with reinforced concrete beams. Here also, a decrease of over 14% has taken place during the past five years. About one third (32.2%) of the cows are still held in cowsheds with wooden beams. An important trend to be noticed is an increase of cowsheds with steel beams and also an increase in the number of cows housed in cowsheds with steel beams.
