Mechanical ventilation with a heat recovery system in renovated apartment buildings

E. Kamendere^{1,*}, A. Zandeckis¹, A. Kamenders¹, J. Ikaunieks² and C. Rochas¹

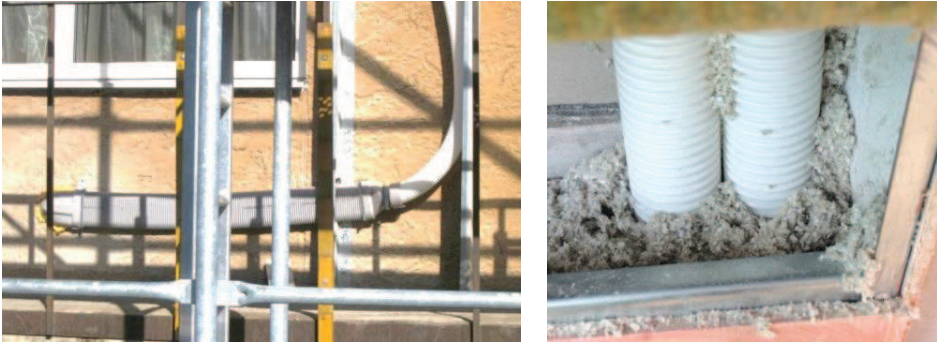
Figure 1. Air ducts are mounted into the facade’s insulation layer, enter the living room through the wall directly behind the heating radiators.

The air supply system is arranged by flexible plastic air ducts (diameter 75 mm) separately to each living room and bedroom. The air ducts are mounted on the building’s facade and enter into living rooms through the wall directly behind the heating radiators (see Fig. 1). The vertical duct parts are built into special wells, which are filled with loose thermal insulation (at least 100 mm). They go down the facade from the attic to the first floor apartments. Fig. 2 shows the air ducts coming from the facade to the attic.

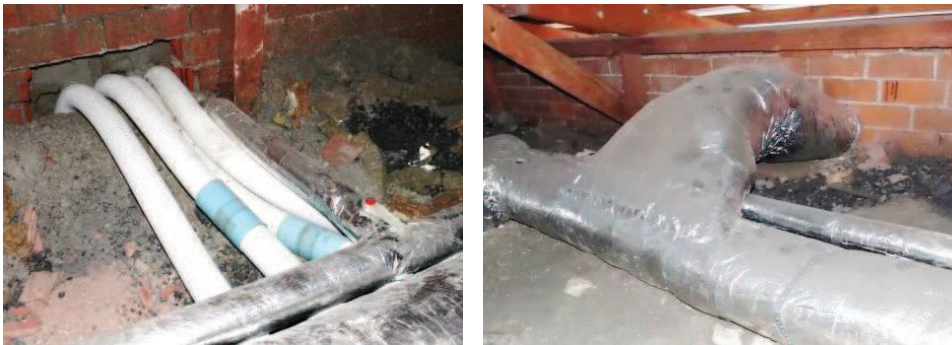
Figure 2. Air ducts coming from the facade into the attic (without insulation and already insulated).

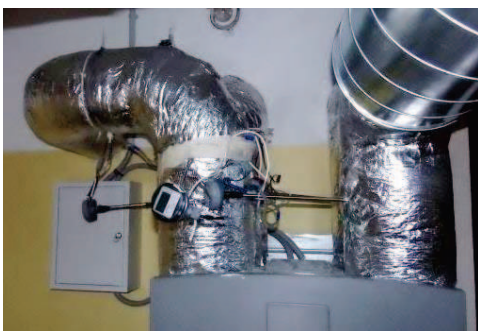
Figure 3. Placement of the combined airflow and temperature transmitter.

For the temperature and airflow rates in both circuits, the combined airflow and temperature transmitter IVL 10/N is used (see Fig. 3).

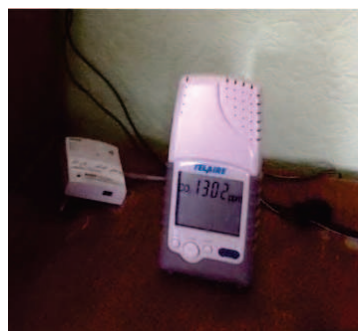
Figure 4. CO₂ sensor *Telaire 7001* and data logger *Hobo* placed in a second floor apartment, 11 Zirnu Street.

To compare indoor air quality, humidity, indoor temperature and CO₂ concentration are measured in two apartments of each building – one with a mechanical ventilation system and one without. For the measurements, the CO₂ sensors *Telaire 7001* equipped with the data loggers *Hobo* (see Fig. 4), which record data about temperature, CO₂ concentration and humidity level with a 5 min interval, are used.

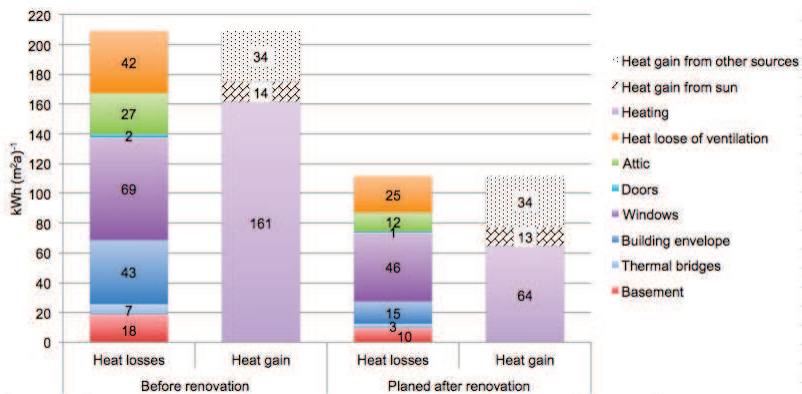
Figure 5. Calculated heat losses and heat gains at 17 Zirnu Street, Cesis, before and after renovation.

It is calculated that after renovation, the building's energy consumption for space heating should reduce from 161 kWh (m²a)⁻¹ to 64 kWh (m²a)⁻¹ in 17 Zirnu Street and from 143 kWh (m²a)⁻¹ to 74 kWh (m²a)⁻¹ in 11 Zirnu Street. Fig. 5 shows the energy consumption before renovation and the expected consumption after renovation in 17 Zirnu Street (kWh (m²a)⁻¹) (i.e. energy consumption per unit of useful area per year). The biggest savings are given by the buildings' envelopes' insulation (saves 28 kWh (m²a)⁻¹), and old window replacement (saves 22–23 kWh (m²a)⁻¹).

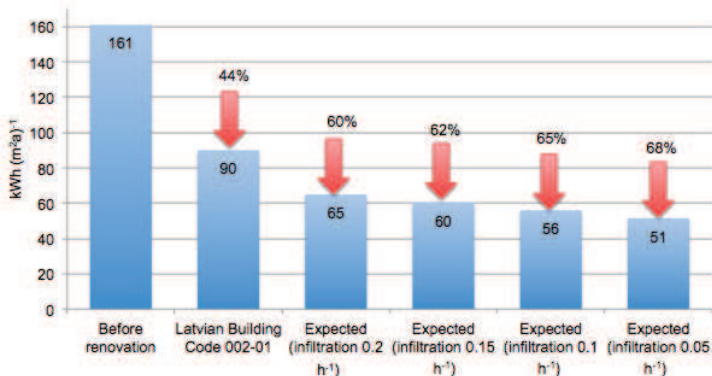
Figure 6. Energy consumption for heating in 17 Zirnu Street, Cesis.

Fig. 6 shows the difference in energy consumption for heating in case of a standard renovation that fulfils the normative requirements and in the current case with a new ventilation system installed. The savings compared to the *before* situation range from 44% to 60%, respectively.

Also Fig. 6 shows how infiltration rate can influence total heat demand. With the infiltration rate 0.05 h^{-1} (the same efficiency of the heat recovery unit: 85%) the energy consumption for heating goes to $51 \text{ kWh (m}^2\text{a)}^{-1}$. It shows that in order to get more from renovation, passive house standards should be strived towards and infiltration rate should be reduced.
